**Flood Control Project Maintenance
Levee Inspections**

Fall 2018 Levee Maintenance Deficiency Summary Report

Reclamation District No. 2064 River Junction

Waterway			Bank	Unit Miles
Unit No. 01 San Joaquin River			Right	5.56
	Spring (March - May)	Summer (June - August)	(September - November) Fall	Winter (December - February)
Unit Maintenance Rating (Fall Only)			A	
Date of Inspection	4/11/2018 - 4/11/2018		10/5/2018 - 10/5/2018	
DWR Inspector	Keith Millard		Luz Dial	
Accompanied By	Mark Veltkamp RD 2064		Keith Veltkamp RD 2064	
	Dan Eavenson		Dan Eavenson

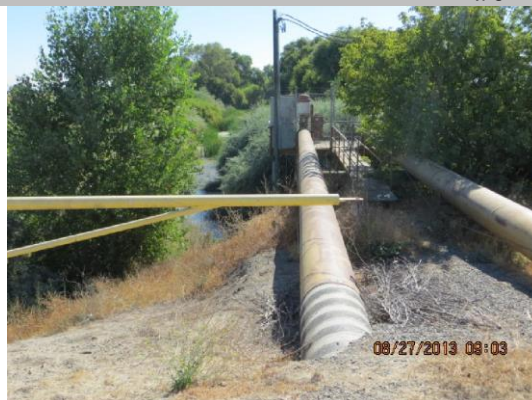
Photo 1 of 3 : UCIP_FA_2018_18718_31286.jpg

LM Start	0.06	Rating **	M	Issue No.	36
LM End	0.06	Issue Type +	En	Location *	
Category	Supplemental			GPS Latitude/Longitude	
				Start	End
Item	DWR UCIP Field Study			37.709725 °	37.709725 °
				-121.267534 °	-121.267534 °
DWR ID	20512				
Comment Code					
Inspector Comment					
FS_ID:18718 DS_ID:20512 EP_NO: 13907 Repair Type: Non-Urgent Crossing Status: Found UCIP Comments: This pipe has less than 1-foot of cover. FIELD_STRUCT_DESC: 1 of 3: 24-inch coated steel drainage discharge pipe through the levee, 2 feet below the crown. Two 100- horsepower and one 75-horsepower pumps on the landside (LS) toe. Siphon breaker on the waterside (WS) shoulder. (Permit No. 13907, 1985 - Reclamation District No. 2064). [Additional Reference(s): DWR Levee Log, 2005]. FS Date: 8/27/2013

Steel storm drain pipe with pump on pier in background.

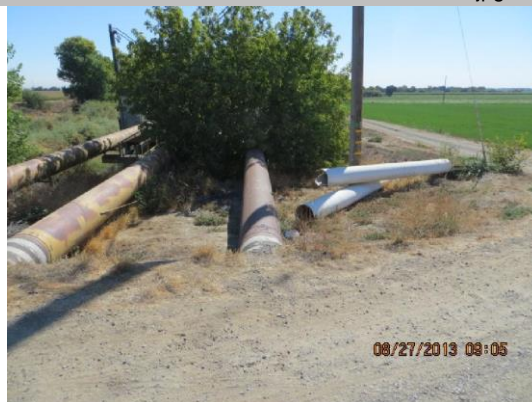
Photo 1 of 3 : UCIP_FA_2018_18720_31294.jpg

LM Start	0.06	Rating **	M	Issue No.	38
LM End	0.06	Issue Type +	En	Location *	
Category	Supplemental			GPS Latitude/Longitude	
				Start	End
Item	DWR UCIP Field Study			37.709672 °	37.709672 °
				-121.267532 °	-121.267532 °
DWR ID	20528				
Comment Code					
Inspector Comment					
FS_ID:18720 DS_ID:20528 EP_NO: 13907 Repair Type: Non-Urgent Crossing Status: Found UCIP Comments: This pipe has less than 1-foot of cover. FIELD_STRUCT_DESC: 3 of 3: 24-inch coated steel drainage discharge pipe through the levee, 1 foot below the crown. Two 100-horsepower and one 75-horsepower pumps on the landside (LS) toe. Siphon breaker on the waterside (WS) shoulder. (Permit No. 13907, 1985 - Reclamation District No. 2064). [Additional Reference(s): DWR Levee Log, 2005]. FS Date: 8/27/2013

Steel pipe visible on LS.

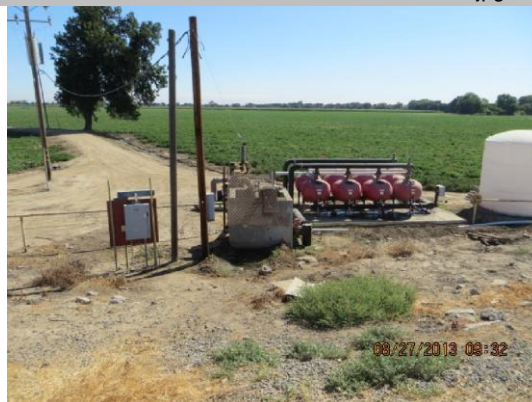
Photo 2 of 3 : UCIP_FA_2018_40792_31376.jpg

Comment Code						
Inspector Comment						
FS_ID:40792						
DS_ID:20533						
EP_NO: N/A						
Repair Type: Non-Urgent						
Crossing Status: Found						
UCIP Comments: Pump and slant pipe missing from structure on WS slope.						
FIELD_STRUCT_DESC: 12-inch concrete encased steel irrigation pipe through the levee, 13 feet below the crown. Slant pump on the waterside (WS) toe. Slide gate in a 36-inch corrugated metal pipe (CMP) riser on the WS shoulder. 6-foot by 6-foot concrete distribution box and filter plant on the landside (LS) toe. 2-inch galvanized iron electrical conduit at the same location. [Additional Reference(s): DWR Levee Log, 2005. USACE San Joaquin O&M Manual 3, December 1968, (HLM 1.24)].						
FS Date: 8/27/2013

Concrete distribution box and filter plant on LS toe.

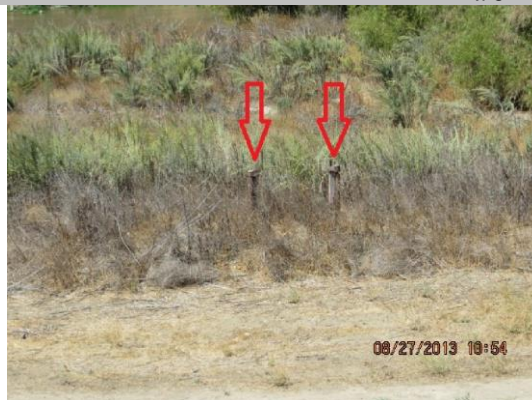
Photo 1 of 1 : UCIP_FA_2018_22731_38463.jpg

LM Start	3.46	Rating **	M	Issue No.	43
LM End	3.46	Issue Type +	En	Location *	
Category	Supplemental			GPS Latitude/Longitude	
				Start	End
Item	DWR UCIP Field Study			37.676751 °	37.676751 °
				-121.264193 °	-121.264193 °
DWR ID	20517				
Comment Code					
Inspector Comment					
FS_ID:22731 DS_ID:20517 EP_NO: N/A Repair Type: Non-Urgent Crossing Status: Indicator Found UCIP Comments: Neet to verify status of pipeline. FIELD_STRUCT_DESC: Underground gas line crossing; depth through the levee and size unknown. Found possible sign posts on WS toe. FS Date: 8/27/2013

Possible sign posts on WS toe.

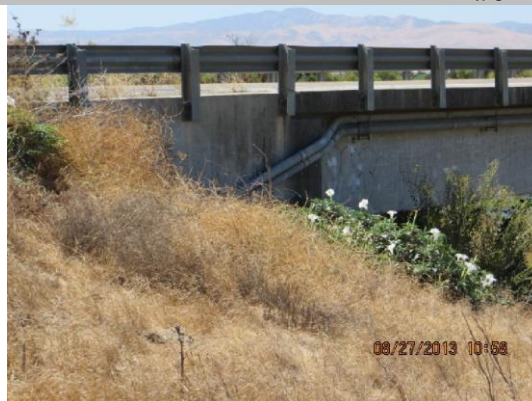
Photo 1 of 1 : UCIP_FA_2018_22790_38826.jpg

Lower conduit visible on DS side of bridge at WS slope.

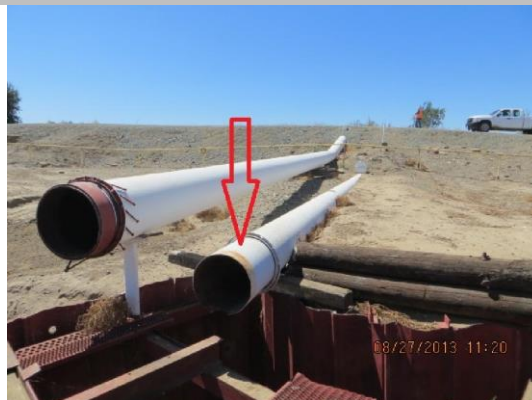
Photo 2 of 3 : UCIP_FA_2018_19044_31843.jpg

Pipe visible at sump off LS toe. No pump or appurtenances.

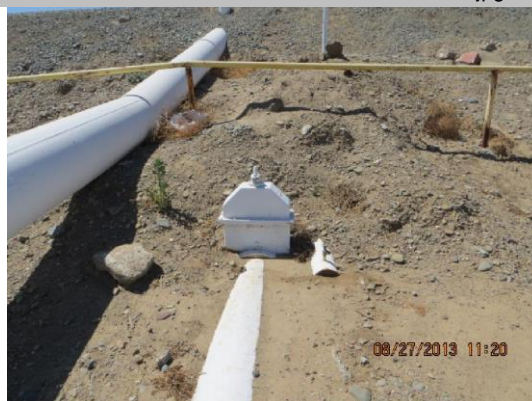
Photo 3 of 3 : UCIP_FA_2018_19044_31842.jpg

Gate valve on LS toe.

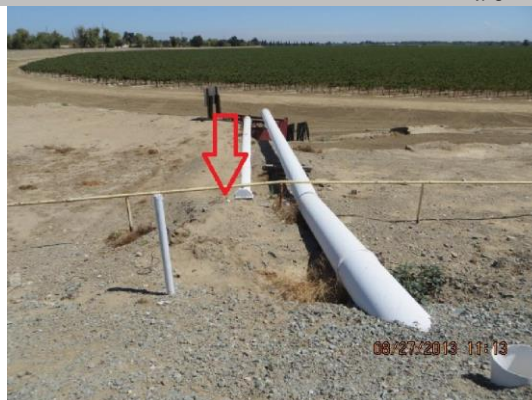
Photo 1 of 2 : UCIP_FA_2018_22732_38465.jpg

Pipe visible on LS toe.

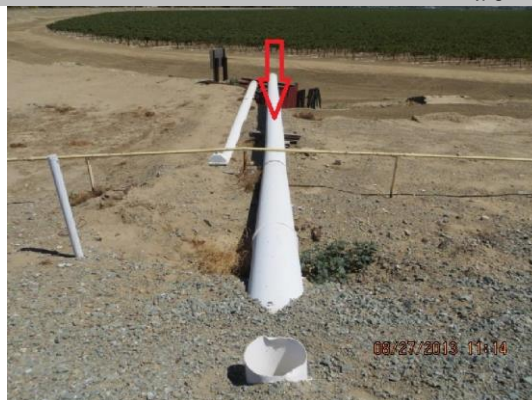
Photo 1 of 3 : UCIP_FA_2018_22733_38468.jpg

Pipe and vent visible on LS slope.

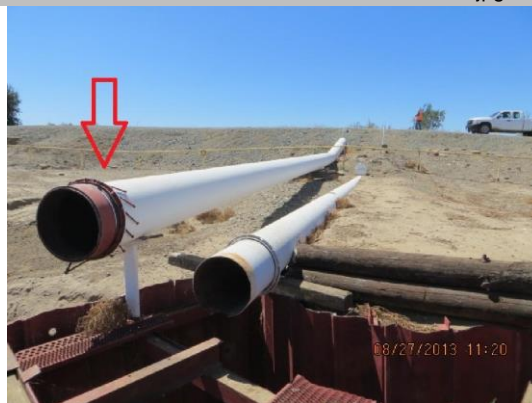
Photo 3 of 3 : UCIP_FA_2018_22733_38466.jpg

Pipe open at pump sump off LS toe.

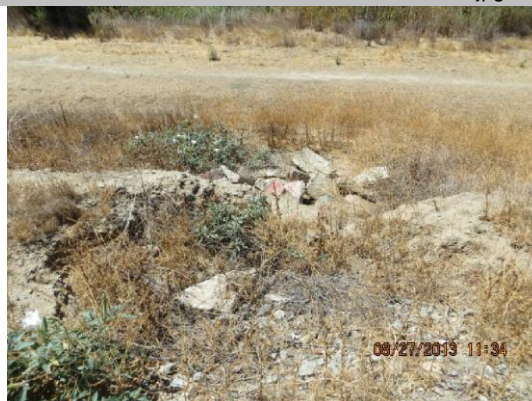
Photo 2 of 2 : UCIP_FA_2018_19046_31848.jpg

Concrete rubble on WS slope possible indicator of abandoned pipe location.

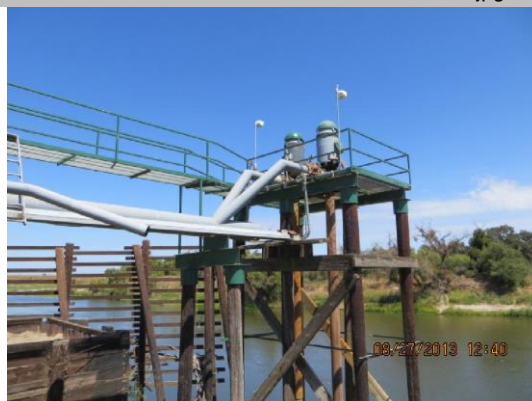
Photo 2 of 2 : UCIP_FA_2018_19063_31860.jpg

Pump platform, walkway, and fender remain in stream. No 24-inch pipe found.

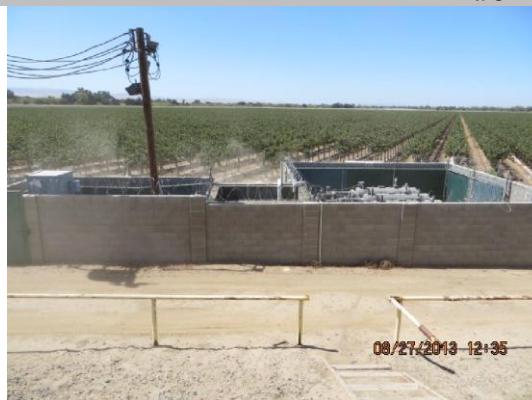
Photo 1 of 2 : UCIP_FA_2018_19064_31863.jpg

Concrete distribution box in center of structure on LS toe.

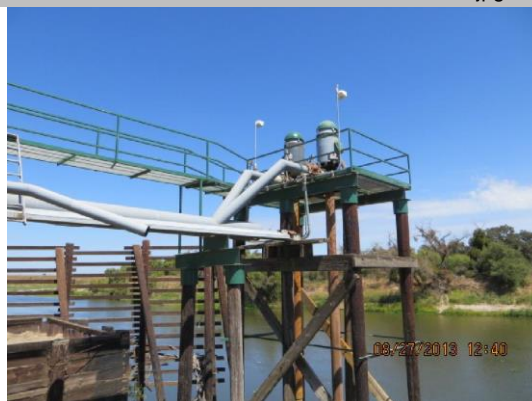
Photo 2 of 2 : UCIP_FA_2018_19064_31862.jpg

Pump platform and fender visible on WS toe.

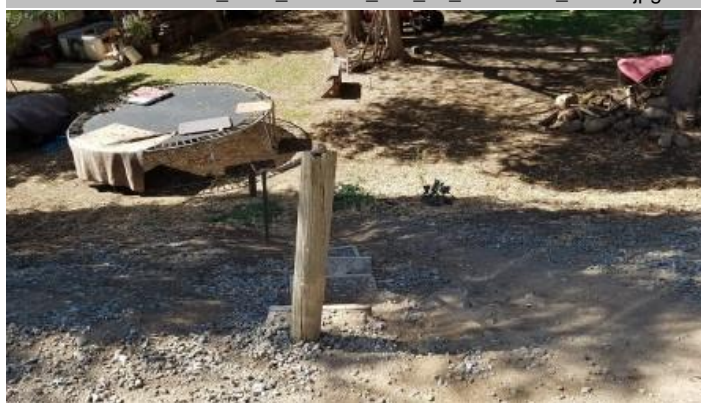
Photo 1 of 1 : FA_2018_RD2064_314_31_20181008_00052.jpg

View of stairway with railing that appears to be without a permit. Fall 2018

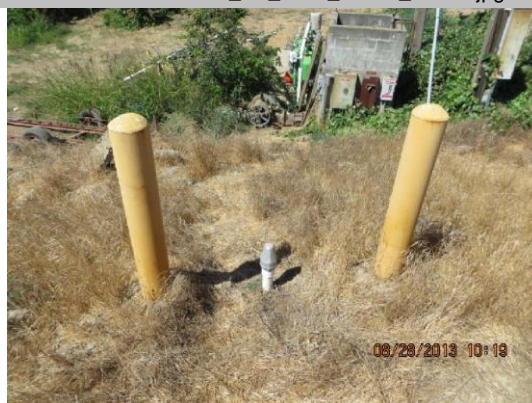
Photo 2 of 3 : UCIP_FA_2018_22095_37721.jpg

Vent on LS shoulder.

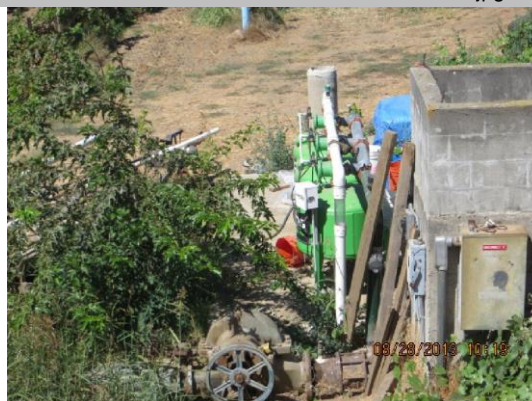
Photo 3 of 3 : UCIP_FA_2018_22095_37720.jpg

Filterplant visible on LS toe.

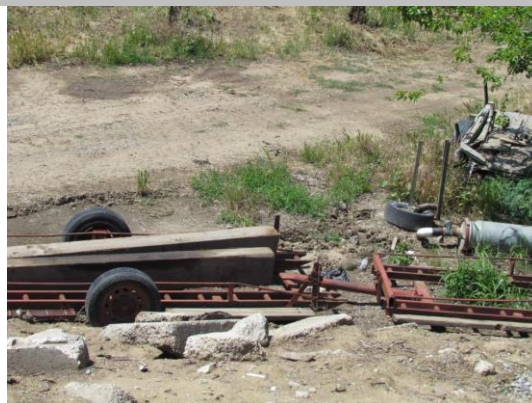
Photo 1 of 2 : FA_2018_RD2064_314_23_20180910_00005.jpg

RD 2064 Landside looking upstream from levee mile 1.97 equipment on the berm.

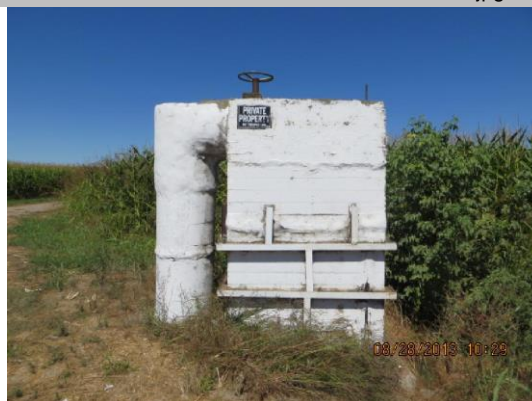
Photo 3 of 3 : UCIP_FA_2018_19086_31952.jpg

Concrete riser in field north of levee likely outlet for cox culvert.

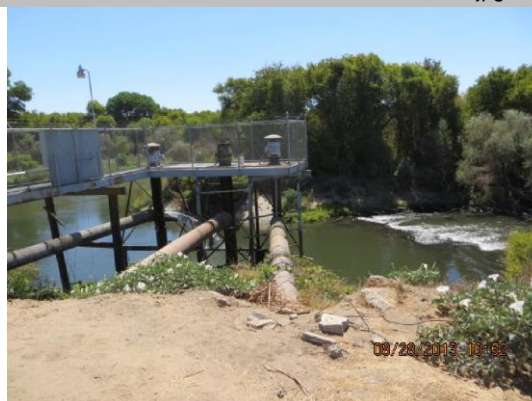
Photo 1 of 3 : UCIP_FA_2018_41075_31963.jpg

Pipe and pump visible on WS berm.

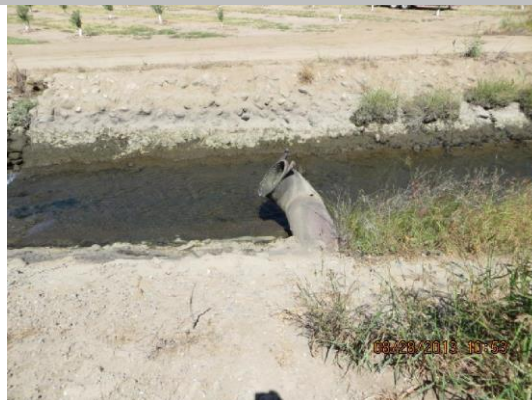
Photo 3 of 3 : UCIP_FA_2018_41075_31961.jpg

Pipe with missing flapgate on LS at concrete ditch.

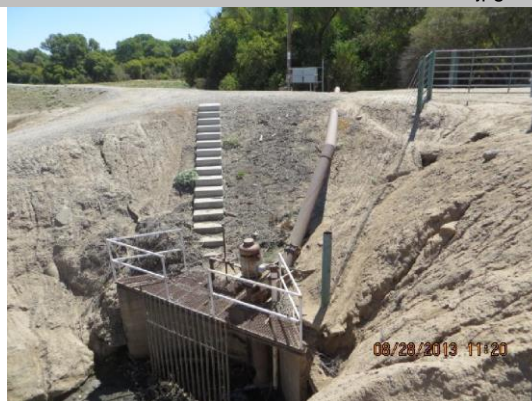
Photo 1 of 2 : UCIP_FA_2018_22107_37736.jpg

Pump for pipe on concrete headwall at LS toe.

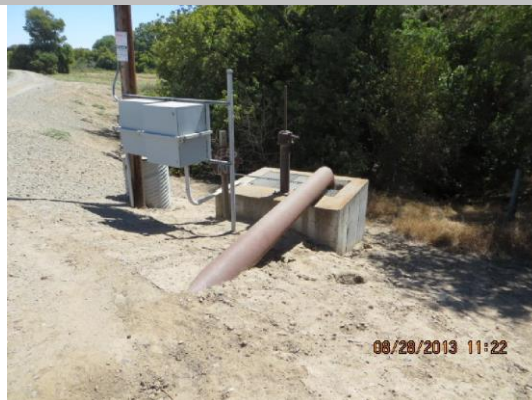
Photo 2 of 2 : UCIP_FA_2018_22107_37735.jpg

Pipe discharges into concrete riser on WS slope.

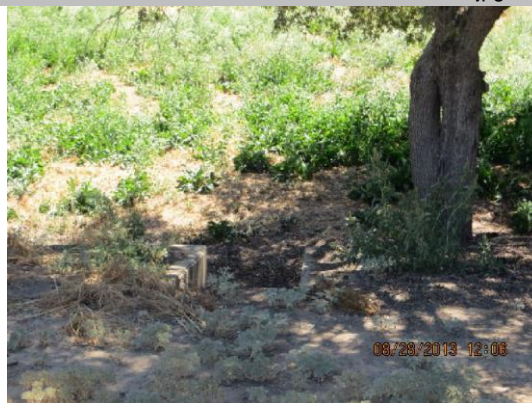
Photo 2 of 3 : UCIP_FA_2018_19117_32068.jpg

Headwall on WS toe.

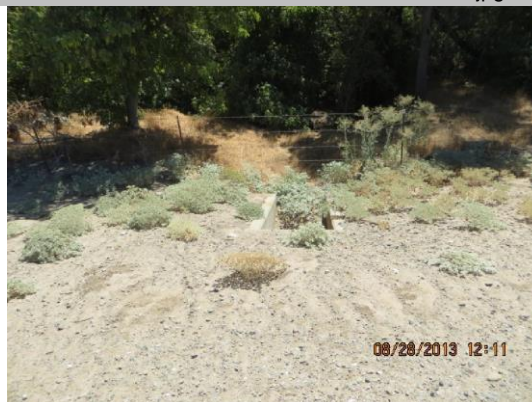
Photo 1 of 3 : UCIP_FA_2018_22793_38842.jpg

Concrete headwall on WS toe.

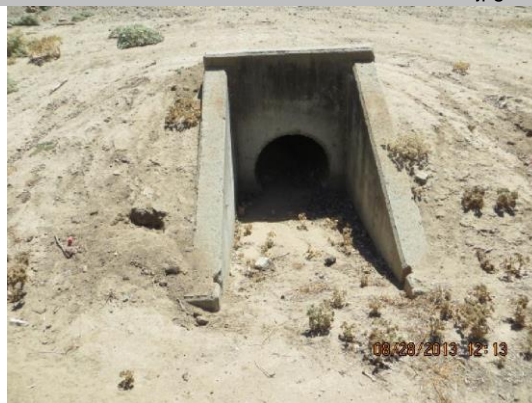
Photo 3 of 3 : UCIP_FA_2018_22793_38844.jpg

Concrete headwall on LS toe.

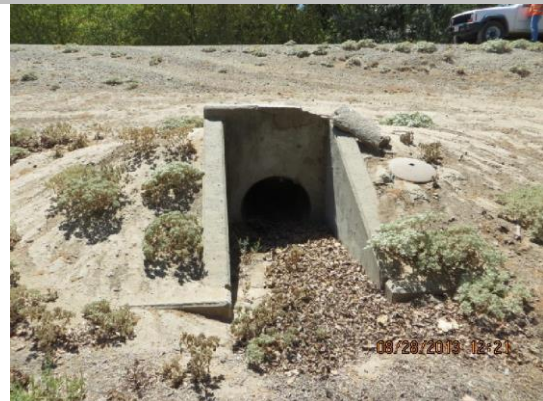
Photo 3 of 3 : UCIP_FA_2018_19122_32081.jpg

Concrete headwall on LS toe.

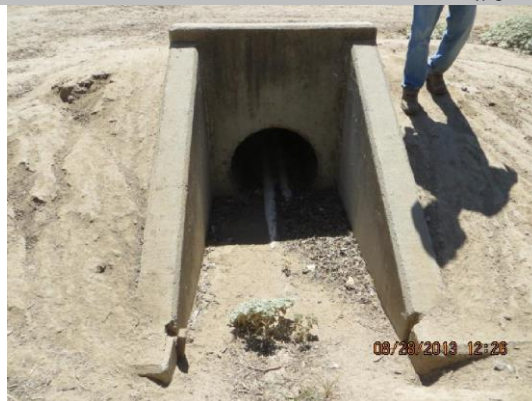
Photo 1 of 3 : UCIP_FA_2018_22109_37742.jpg

PVC conduit at left on LS toe.

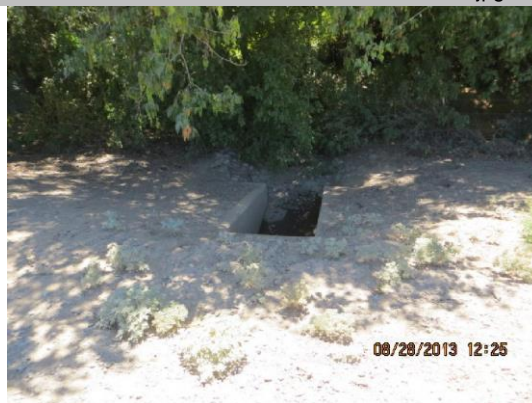
Photo 2 of 3 : UCIP_FA_2018_19143_32121.jpg

Concrete headwall on WS toe.

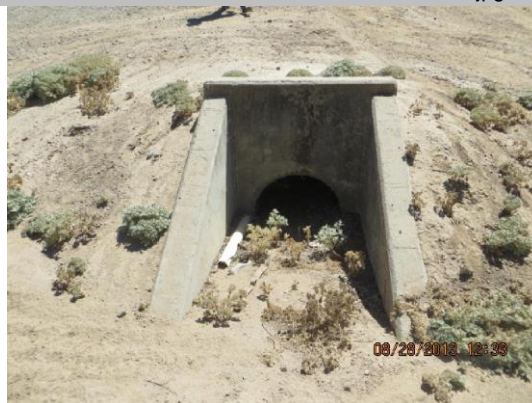
Photo 3 of 3 : UCIP_FA_2018_22794_38853.jpg

Concrete headwall on LS toe.
